P-ISSN: 2706-7483
E-ISSN: 2706-7491
IJGGE 2023; 5(2): 95-110
Received: 01-05-2023
Accepted: 08-06-2023

Slope stability analysis at soapstone mining sites in Nyamarambe, Kisii County, Kenya

Kayusi Ondabu Fredrick, Maarifa Ali Mwakumanya and Mwakio P Tole

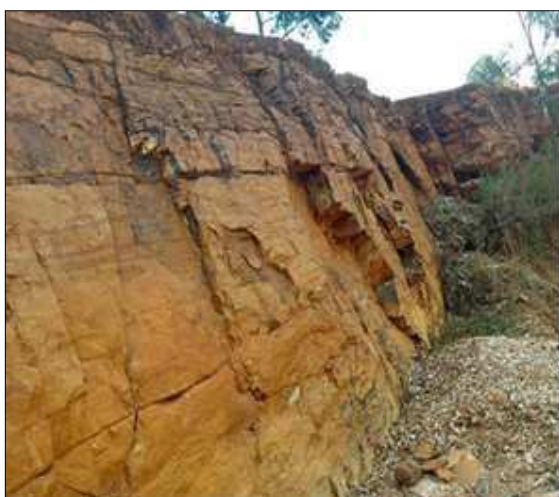
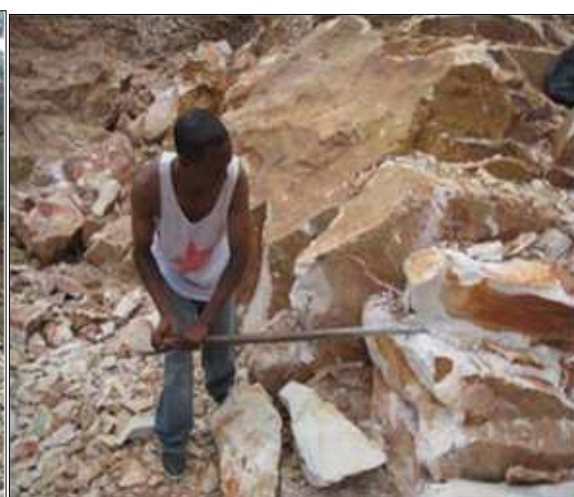
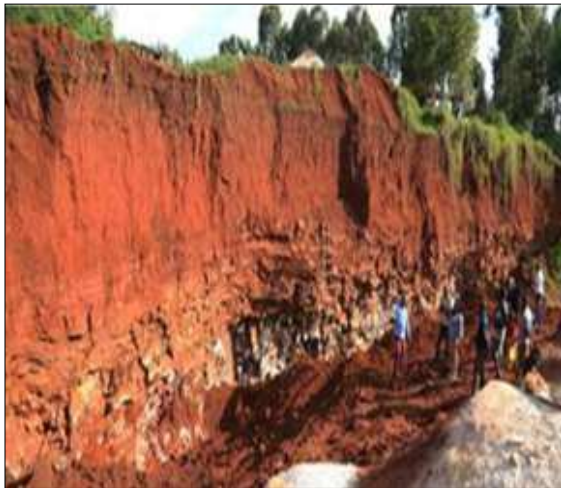
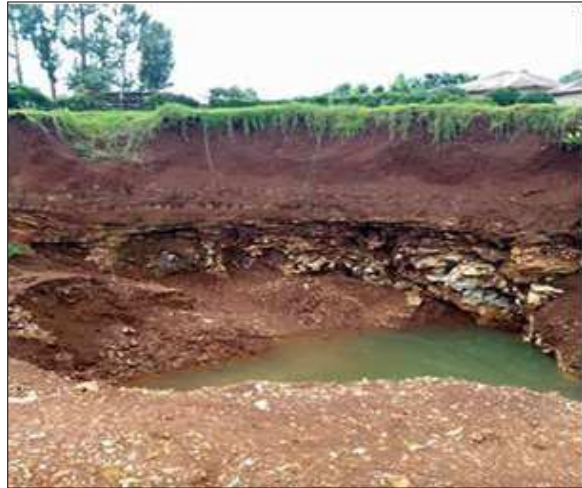
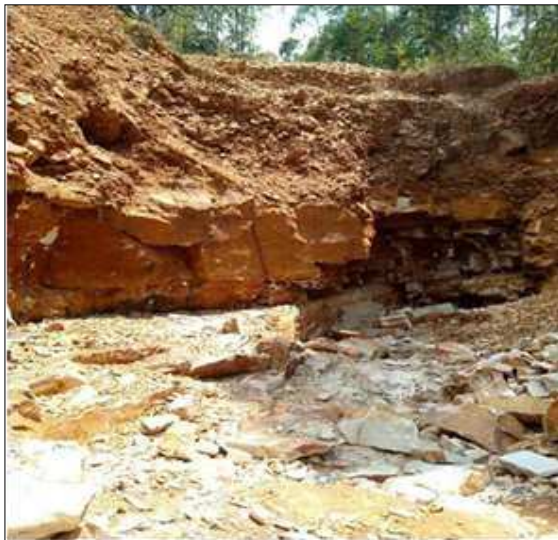
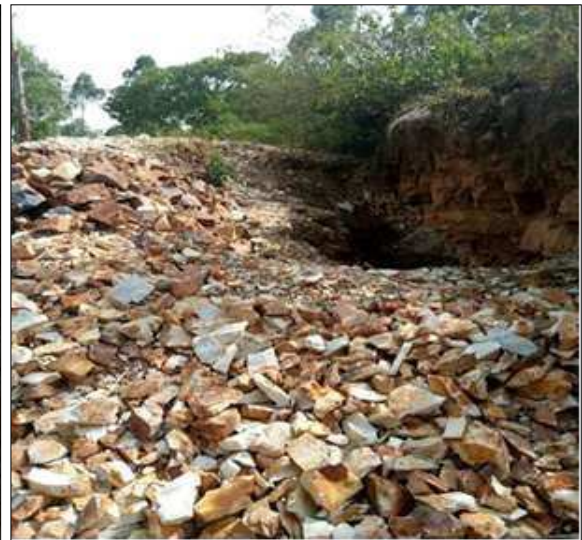
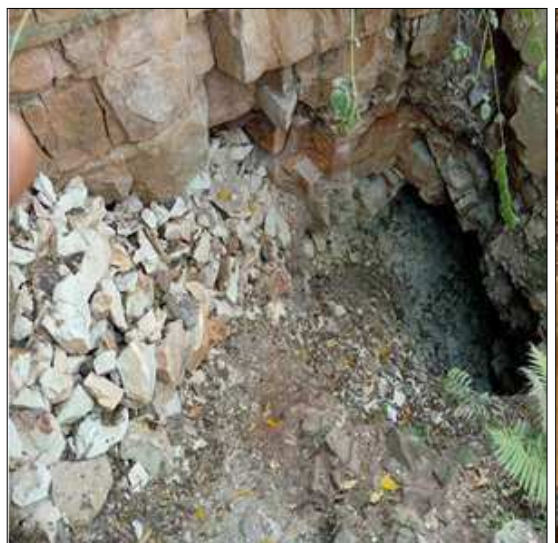
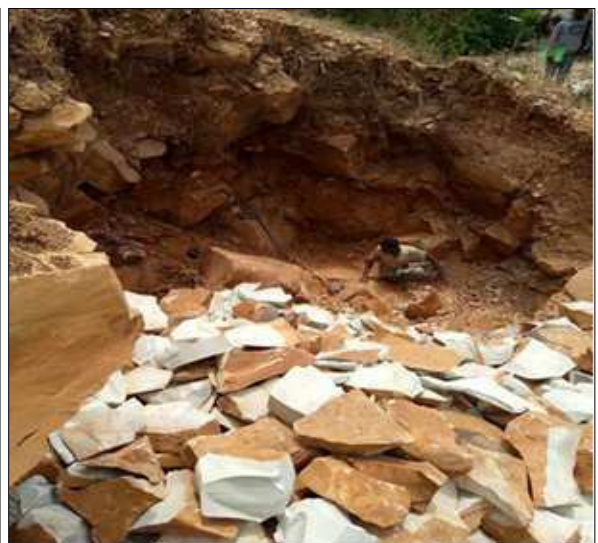
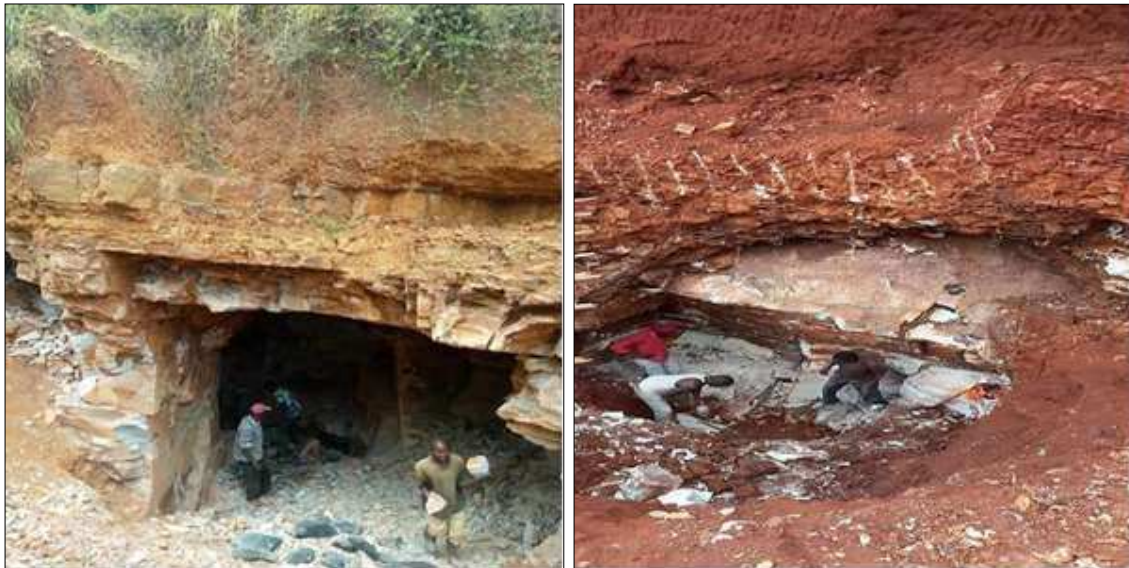
Fig 5: Geological Properties and Unstable Slopes of Soapstone Mines

A. Rock Discontinuities (joints, cracks)

B. Splitting Soapstone Rocks

C. Loose Topsoil and Soapstone Rocks

D. Water Infiltration through Slope Face

E. Soapstone Cavity and Pits

F. Deep Open Pit and Dumped Debris

G. Hanging Soapstone Rock and Void

H. Crushing Soapstone Rocks

I. Underground Pit & Overhanging Rock

J. Soapstone Open Pit Slope Face

Figure 5 (A&C) shows a large mass of soapstone rock slanting on the quarry slope face after excessive excavation on the hillside. The geological structure of the soapstone slope face exhibits discontinuities, joints, cracks and fissures exposed to weathering agents which accelerate disintegration of the rock mass resulting in weakening its shear strength. Further, the protruding rock outcrops exfoliate from the main soapstone rock mass as shown in Figure 5 (A). Figure 5 (B) shows the mechanical splitting of the large soapstone rock mass into workable sizes. The splitting leaves hanging boulders of rocks and weakens the shear strength of the rock mass causing rock slides and falls. Figure 5 (C) shows unconsolidated topsoil and soapstone rock strata. It also shows traces of topsoil washed down the soapstone rock slopes. Figure 5 (D) shows water infiltration paths through the soapstone rock slope surface and stagnated water in the open pit which reduce cohesion and frictional resistance causing unstable slopes.

Fig 5: (A, E, & J) shows deep-cut open pits with sharp dipping of soapstone rock bedding planes into the excavated opencast mines. The increased slope angles and heights cause the downward sliding of rock masses on unstable slopes under the influence of the increased force of gravity. Further, Figure 5 (F, G & H) show geological disturbances such as faults, joints, fissures and weathered debris. Steepened weathered rock slopes with dipping geological bedding plane structures cause slope instability in the mines due to weakened shear strength. Figure 5 (H, I & J) shows dangerously overhanging rock masses and topsoil layers with no firm base supporting structures hence at risk of collapsing at any time. The weak weathered rock mass beneath the loose topsoil and rock layers slope becomes unstable and highly susceptible to failure.

Figure 5 (F, G & I) shows caves, cavities and voids. The caves and voids in the soapstone rock mass have developed because of deep excavation into the hillsides. The cave in Figure 5 (I) poses a danger to the safe production of soapstone rocks. The overlying thin roof slab tends to be potentially unstable and may collapse at any time if subjected to high infiltration and content of groundwater and excessive excavation.

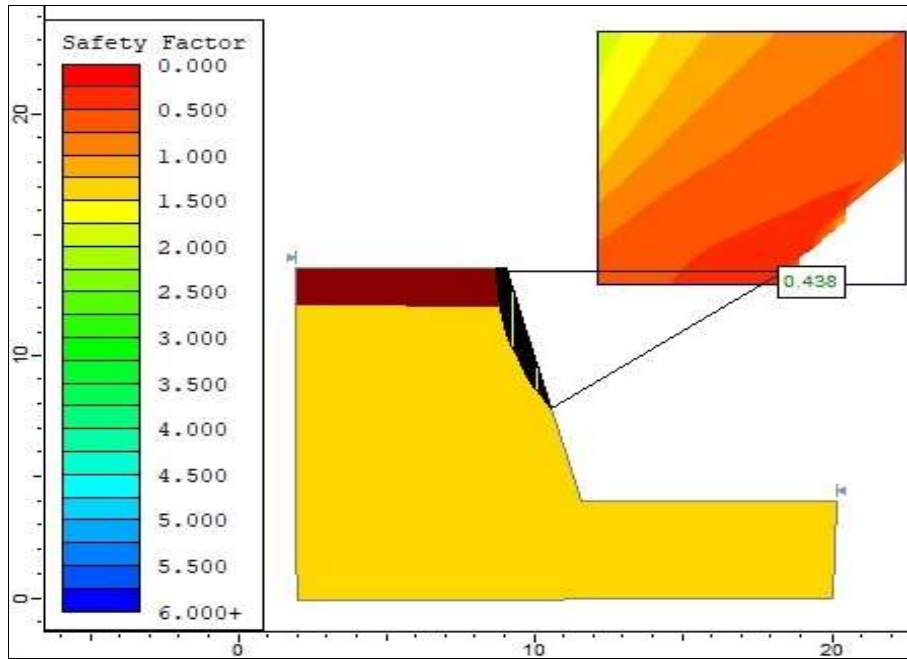
Fig 7: FoS of Nyabigena Quarry Slope

A. 2-D Nyabigena Soapstone Open Pit

In constant internal parameters, the value of the factor of safety (FoS) is 0.438 (unstable) with an overall slope angle of 74.8 degrees a height of 9.48 meters and slope distance (hypotenuse) of 9.85 meters.

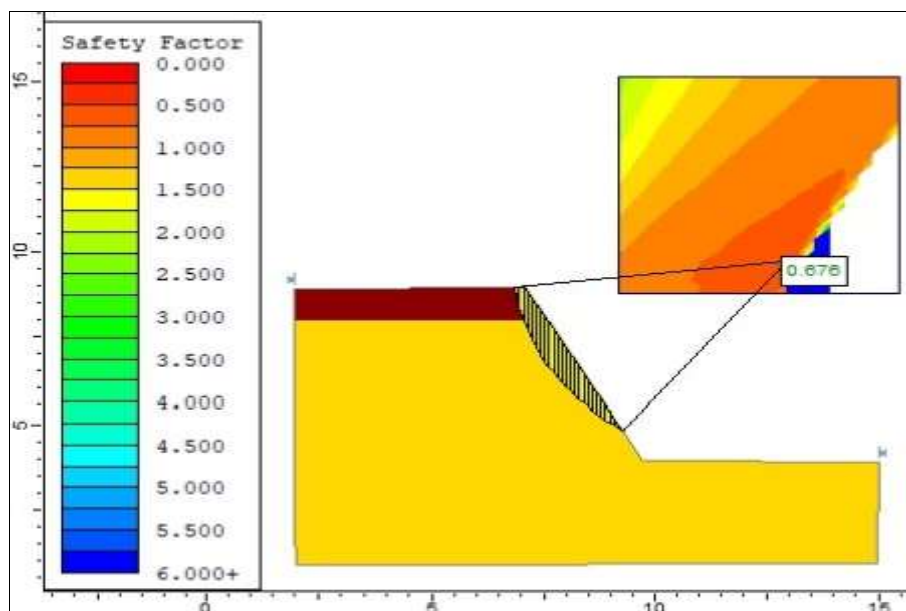
Fig 12: FoS of Nyagichenche Quarry Slope

F. 2-D Nyagichenche Soapstone Open Pit

In constant internal parameters, the value of the factor of safety (FoS) is 0.676 (unstable) with an overall slope angle

of 61.7 degrees, a height of 4.98 meters and a slope distance (hypotenuse) of 5.66 meters.
